## Case Report: Management of Late Dental implant failures

### ABSTRACT

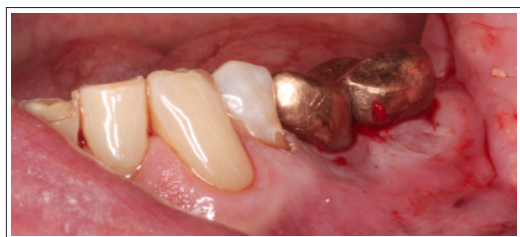
A 72-year-old male patient presented to our periodontal practice with implants #18 and #19 (4.7mmX11.5mm Legacy 2 Implant direct implant) that were placed by another dentist 10 years earlier. Clinically, the patient presented with edematous tissue, poor oral hygiene, deep probing depth and inflammation around #18 and #19. X-rays showed severe bone loss around #18 and moderate bone loss #19. (Figures 1a and 1b) He had Grade II wear facets generally in his mouth and had not been wearing his maxillary night guard. Based on our findings it was determined that removal of implant #18, degranulation and regeneration of the site with freeze dried bone allograft (FDBA) and membrane barrier would be necessary in addition to debridement of implant #19 and grafting

**Figure 1a:** Initial presentation showing inflammation, around implants #18 and #19

of defect present around it. Followed by replacing implant crown for #19 with an interim crown with a narrower occlusal table and light occlusal contact and #18 with a new implant after site has complete healing. Impressions for a new maxillary night guard was also completed.

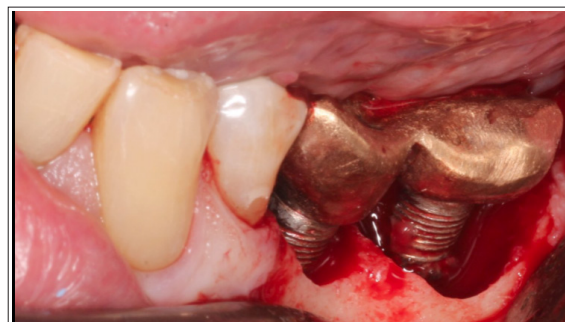
**Figure 3:** Clinical picture showing severe bone loss #18 and moderate bone loss #19

Overloading of the implants resulted in severe Periimplantitis around implant #18 and moderate Periimplantitis around implant #19. Over contouring of the bridge resulted in cantilever forces on the implants as well as patient being a bruxer and not wearing his night guard contributed significantly to his implant failure. Additionally, failure to attend routine periodontal maintenance visits was also a major contributing factor to his implant failure. Attending periodontal maintenance visits for patients who have implants, especially when they are at risk of overload due to parafunctional habits, is essential because complications can be treated early and prevent implant failure.

The bridge was sectioned to allow removal of #18. Under local anesthesia a flap was raised, (Figure 2 and 3) extraction of implant #18 was performed using elevator and forceps, the extraction site was degranulated and irrigated with saline. Ridge preservation was performed utilizing freeze-dried bone allograft (FDBA) and bioabsorbable vicryl mesh membrane. #19 was debrided, irrigated with saline and FDBA allograft and bioabsorbable vicryl mesh membrane used for guided bone regeneration (GBR). Closure was performed using PTFE sutures. Prescriptions for Amoxicillin 500mg (twenty-one tabs, 1 tab three times daily for 1 week) was given. Patient was advised to use over the counter pain medication and to use saline rinses twice daily for 1 week. He presented in two weeks for suture removal and was healing well from the procedures, his night guard was inserted. His general dentist replaced his implant crown for #19. He presented back for follow up four months later (Figures 4 and 5).

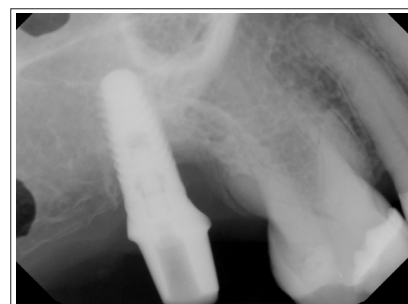
**Figure 10**

to save his implant. Based on his clinical findings, probing depth showing deep pockets mesial and distal #2 and x-rays, he was diagnosed as having Moderate Periimplantitis. His abutment was removed and replaced with a healing abutment (Figures 10, 11a and 11b). Under local anesthesia, a flap was created and his implant was debrided using plastic scalers. His implant was irrigated using saline solution, guided bone regeneration was completed using Freeze dried bone allograft (FDBA) and bioabsorbable vicryl mesh membrane. Closure of flap was completed using PTFE sutures. Patient was given prescriptions for Motrin 600mg 12 tabs 1 tab every 6 hours as needed for pain, Amoxicillin 500mg (21 tabs, 1 tab three times daily for 1 week) and advised to use saline rinses for 1 week. Patient presented for suture removal in 2 weeks and was healing well. Following 6 months of healing, he was seen by his general dentist to address his crown and we inserted his nightguard (Figure 12). Patient has kept up with his maintenance visits and use of his night guard.

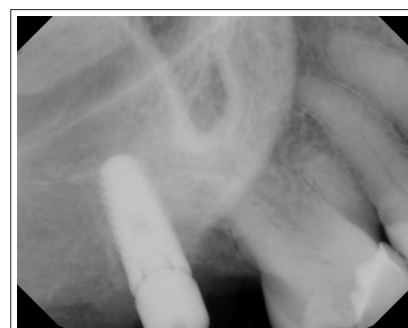
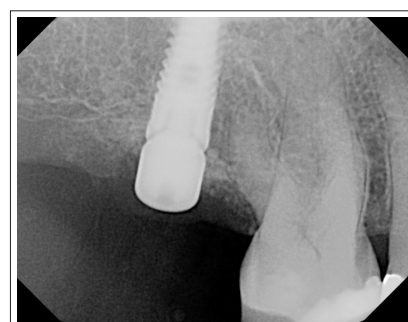
**Figure 11a and 11b:** healing abutment placed back and Healing after Guided bone regeneration(GBR)
