Crystalline Phase Change Due to High-Speed Impact on Steel

ABSTRACT

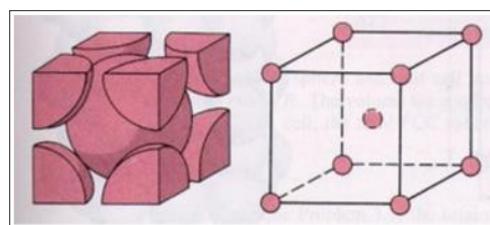
Figure 1: BCC Structure. Atoms are arranged at the corners of the cube, with another at the cube center. The coordination number is 8 [5].

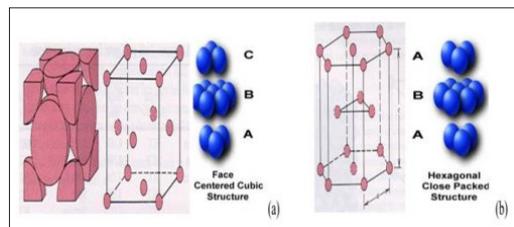
Figure 2: (a) FCC Structure Atoms are arranged at the cube's corners with other atoms at the cube Center. The coordination number is 12. (b) HCP Structure Atoms are positioned at the corners of the cube with other atoms at the cube center. The coordination number is 12 [8].

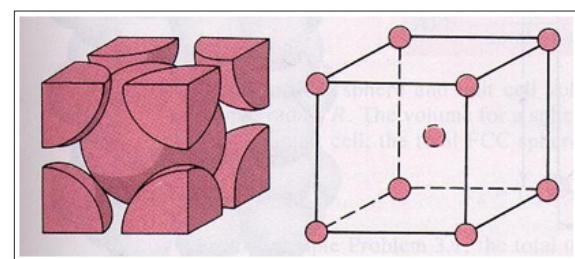
Figure 3: BCC Structure. Atoms are arranged at the corners of the cube with another at the cube center. Coordination number is 8 [5].

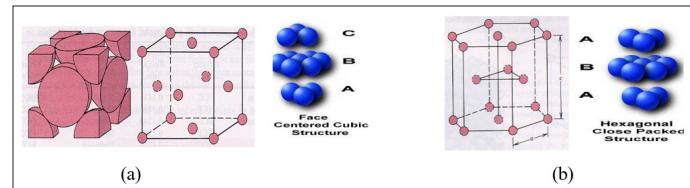
Figure 3: (a) FCC Structure Atoms are arranged at the corners of the cube with other atoms at the cube Center. Coordination number is 12. (b) HCP Structure Atoms are arranged at the corners of the cube with other atoms at the cube center. Coordination number is 12 [5].

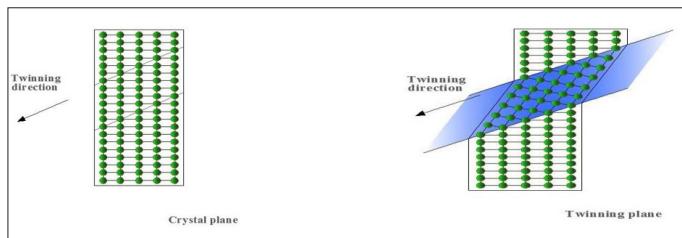
Figure 4: Twinning occurs by cooperative displacement of atoms [8].

When the crystal is subjected to stress or temperature/pressure conditions different from those under which it originally formed, two or more medial crystals are formed in an orderly, periodic fashion. These symmetric intergrowths of crystals are called twinned crystals. Points of one crystal are shared as lattice points with another crystal, adding apparent symmetry to the crystal pairs. Twinning is considered mysterious phenomena. However, twinning is essential to recognize because this feature is used for mineral identification. Twinning occurs by cooperative displacement of atoms as exemplified in the [111] direction.

The result of twinning is to produce a permanent shape change (plastic deformation) [7]. Under certain circumstances, crystals, specific conditioning, and re-formation occur, creating the phenomenon that we call twinning. Twinning occurs when two separate crystals share some of the same crystal lattice points symmetrically. The result is a rebirth of two distinct crystals in a variety of configurations. A twin boundary, or composition surface, separates the two crystals. The deformity caused by twinning explained by the twinning surface and direction. Atomic

dislocation may generate twinning shear. Twinning appears as a mirror image on the surface. The distance of each atom's position is related to the original system and the twin lattice [8,9].

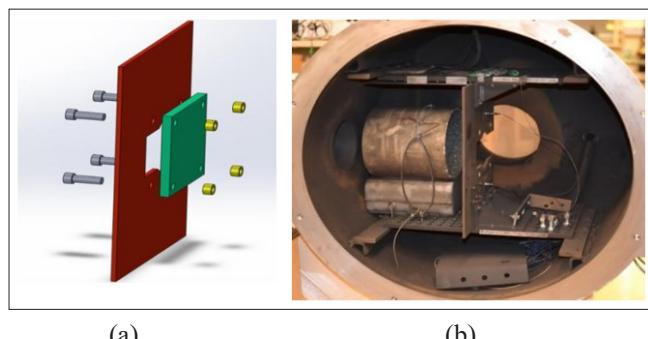
Figure 4(a) shows the target plate in green and the support plate in red. Figure 7(b) shows the support plate mounted inside the target chamber.

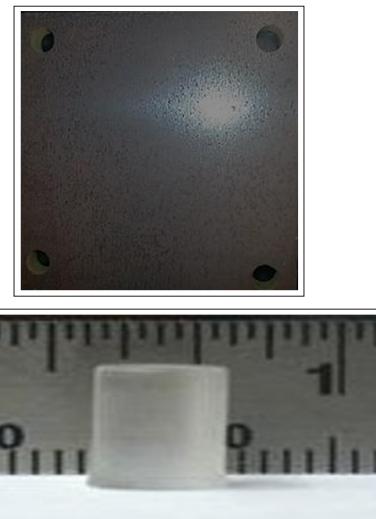
Figure 6: A36 Target plate before impact and Lexan projectile (not shown to the same scale) [13].

The target plates are cut into square shapes that fit conveniently inside the target chamber. All target plates have the same dimensions. They are 15.2 cm x 15.2 cm x 1.27 cm. They are

impacted with a cylindrical Lexan projectile with a 5.6 mm diameter and 8.6 mm length. An A36 steel target plate and Lexan projectile are shown in Figure 5. The target plates are impacted with projectiles at speeds selected to induce significant plastic deformation without completely penetrating the target. The visually observable damage on the front and back sides of a typical target plate is shown in Figure 6. The crater diameter can be slightly more than three times the projectile diameter (~ 17 mm) for the faster impact velocity. The depth of the crater measured from the flat region on the front surface was up to 6.6 mm and the bulge on the back surface was up to 3.5 mm, measured from the flat region of the back surface [11].

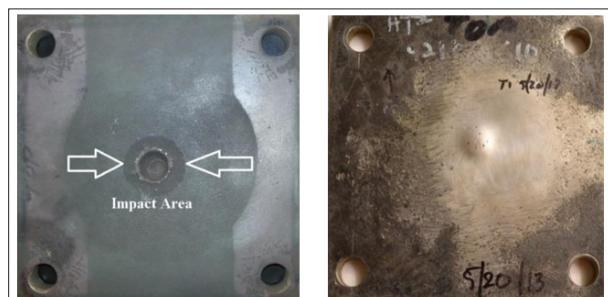
Figure 7: Visible damage on an A36 steel target on the Front sides (Left) and backside (Right).

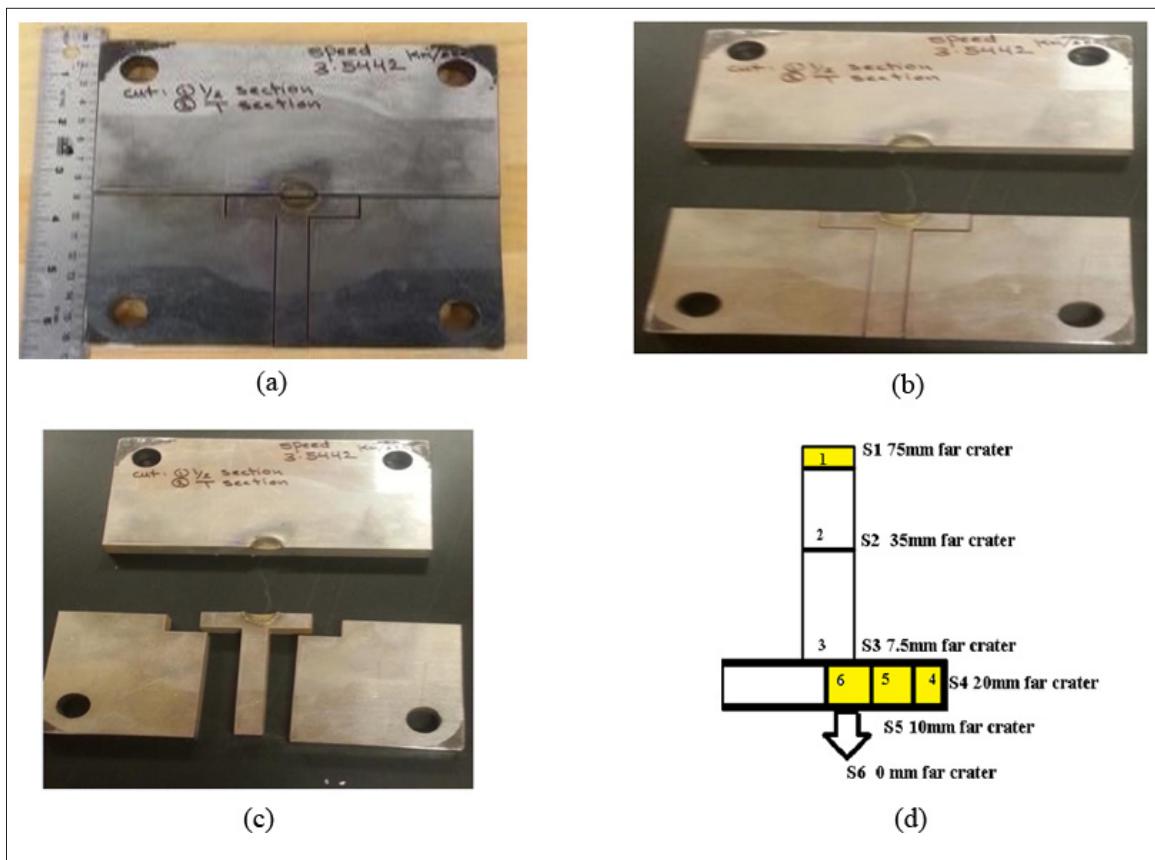
Figure 8: (a) Cut lines on a target plate, (b) Target cut in half, (c) Finished T-section ready for further Dividing and (d) T-shaped bars with dimensions

Each impacted plate was initially cut in half through the center of the impact crater. The target materials were further cut into a T-Shape so that six different cross-sections could be exposed and prepared for microstructural analysis. All cutting procedures were controlled to minimize the addition of temperature to the cutting surfaces. A water jet machine was used to make the necessary cuts in the steel targets to obtain the T-shaped bar. The water jet process cools while cutting to help eliminate heat-induced changes to the microstructure. Figure 7 shows the results of cutting at various stages, including a target plate being prepared for water jet cutting. A top view of the T-shaped bar is shown in Figure 7, along with the corresponding dimensions.

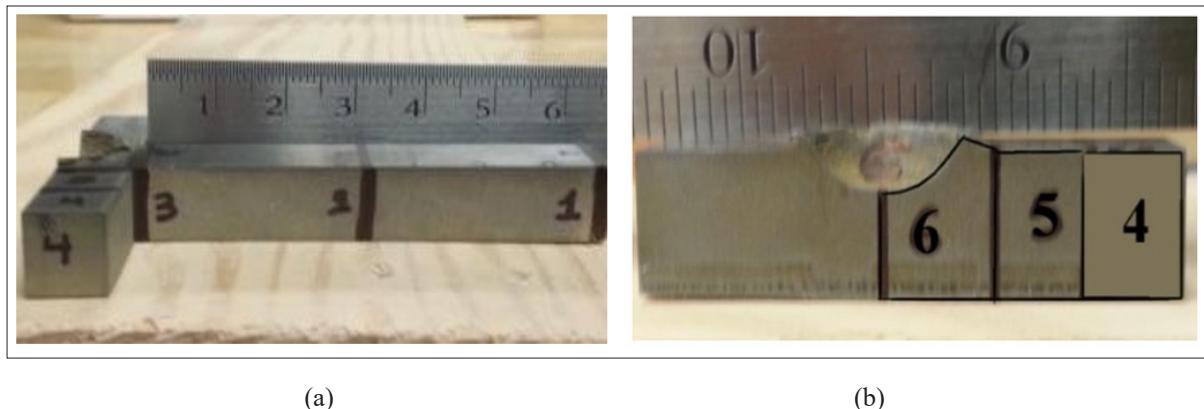
Figure 9: Location of six cross-sectional regions used for microstructural analysis [13].

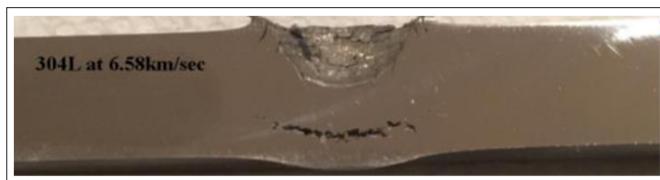
Figure 10: Crater zone in 304L targets subject at 6.58Km/s.

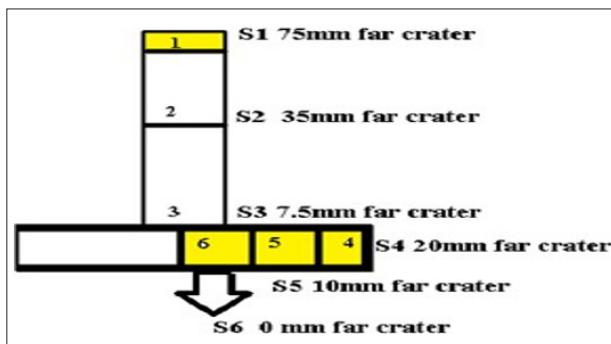
Figure 12: T-shaped bars with dimensions regions used for microstructural analysis.

Each impacted plate was initially cut in half through the center of the impact crater. The target materials were further cut into a T-Shape so that six different cross-sections could be exposed and prepared for microstructural analysis. All cutting procedures were controlled to minimize the addition of temperature to the cutting surfaces. Figure 4 shows the Selected Locations of the center of the slide for EBSD viewing are designated as follows:

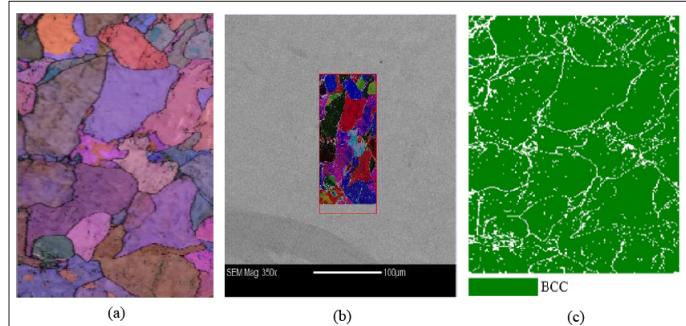
Figure 14: EBSD data from non-impact A36 steel a) grain, b) 350X magnification and the original length of the map, and c) phase map

The images shown in Figure 9, obtained from EBSD microscopy, show the grain structure of A36 steel that has not been impacted. Figure 9 indicates three views that explain grain, the 350X magnification, and the original length of the map and phase. Table 2 lists non- impact material phase ratios.

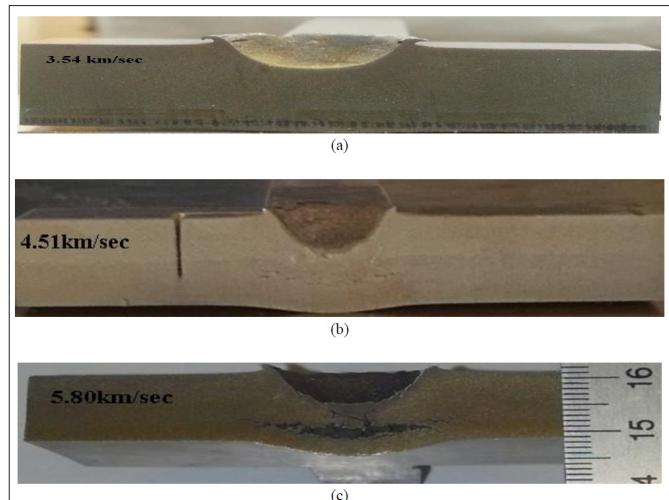
Figure 15: Damage zone in A36 steel targets subject to impact velocities of (a) 3.54 km/s, (b) 4.51 km/s, and (c) 5.80 km/sec [13].

One A36 target plate from each impact velocity condition was evaluated. The geometry of the damage zone in the A36 target for the three different impact velocities is shown in Figure 10. Depth and width of the crater on the front side is measured with calipers. Enlarged views of the impact section, which is given special attention in scanning for more than one point on the surface of that section, are shown in Figures 10 (a), (b) and (c) for the A36 steel at different impact velocities.

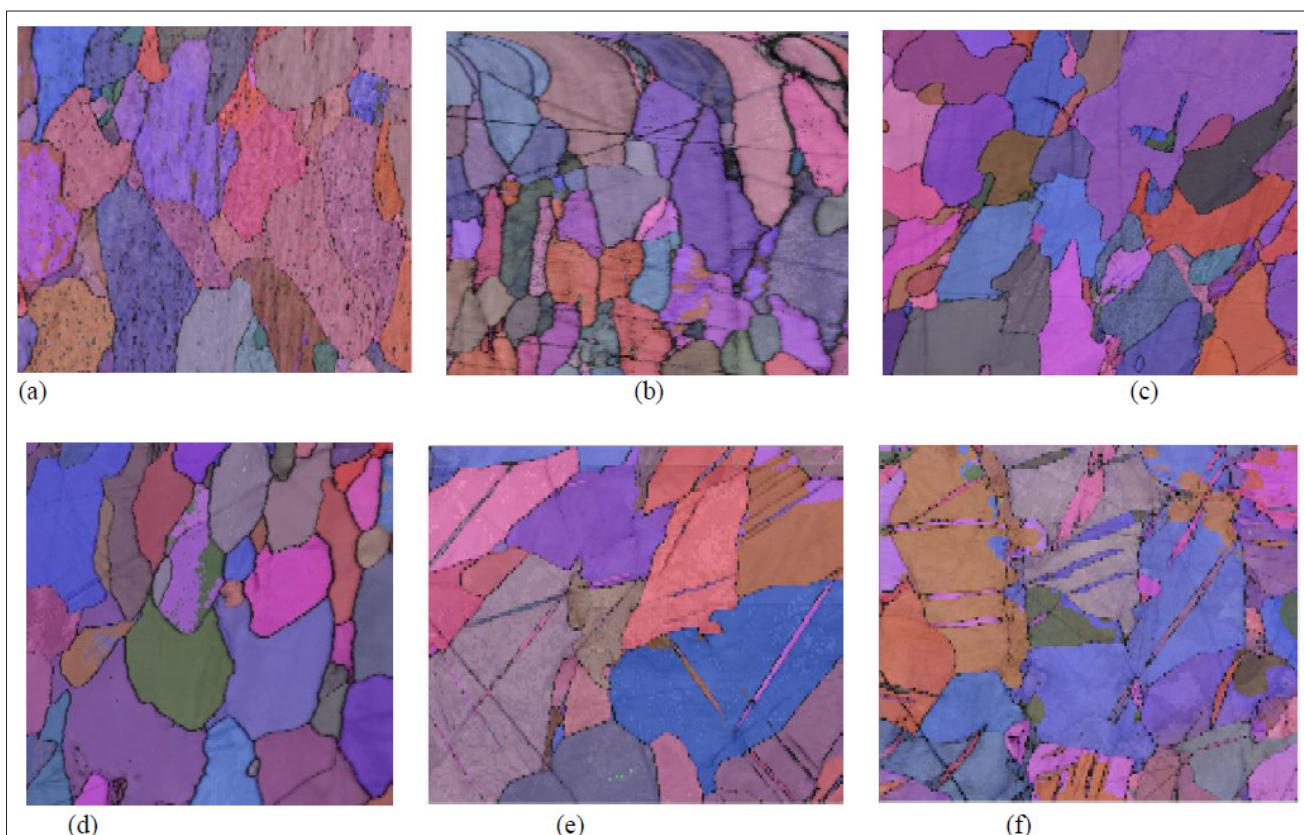
Figure 16: Sample for impacted A36 steel at 3.54 km/sec all cross-sections

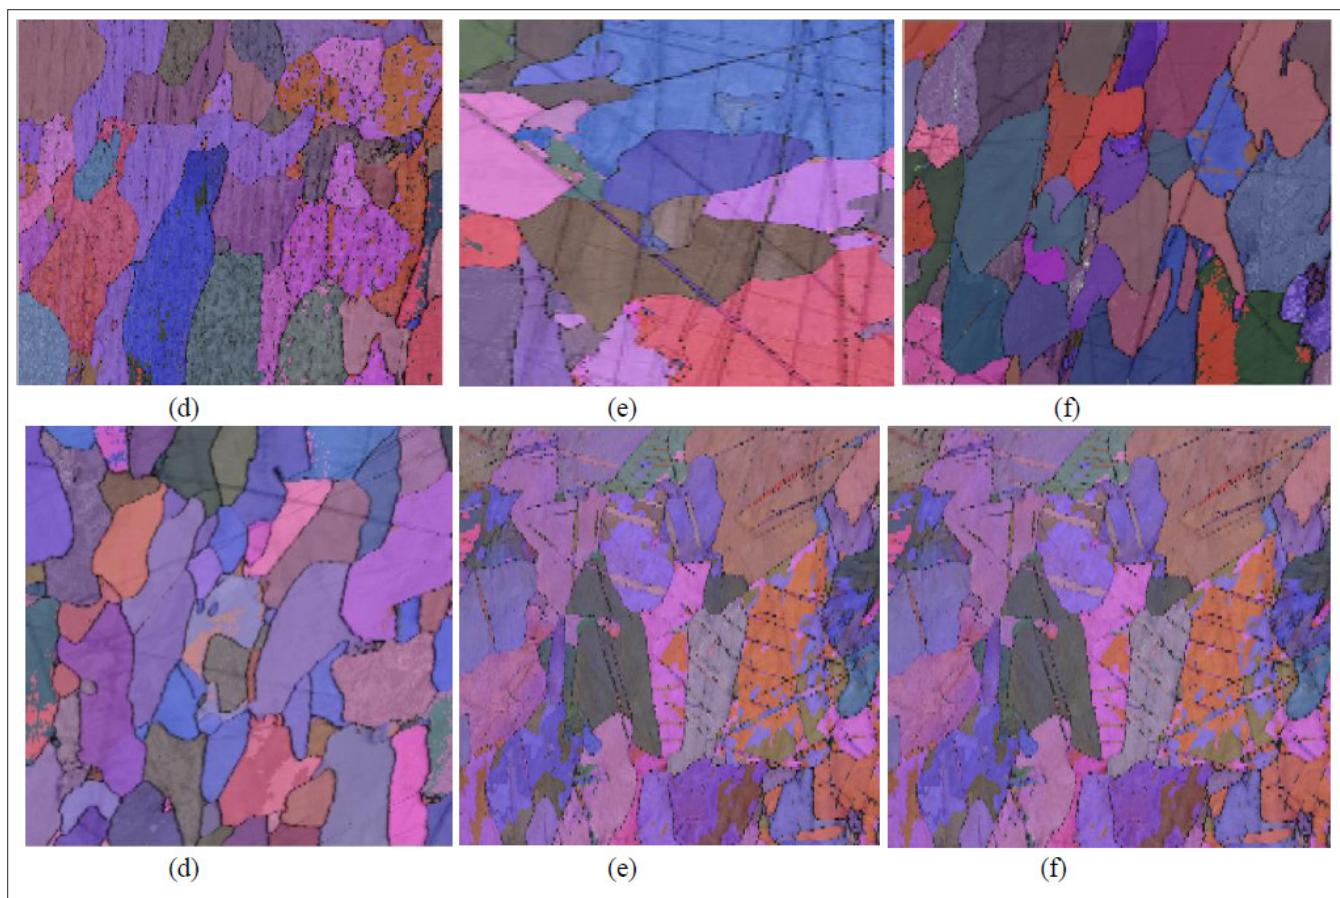
Figure 17: Sample for impacted A36 steel at 4.51 km/sec all Cross-Sections

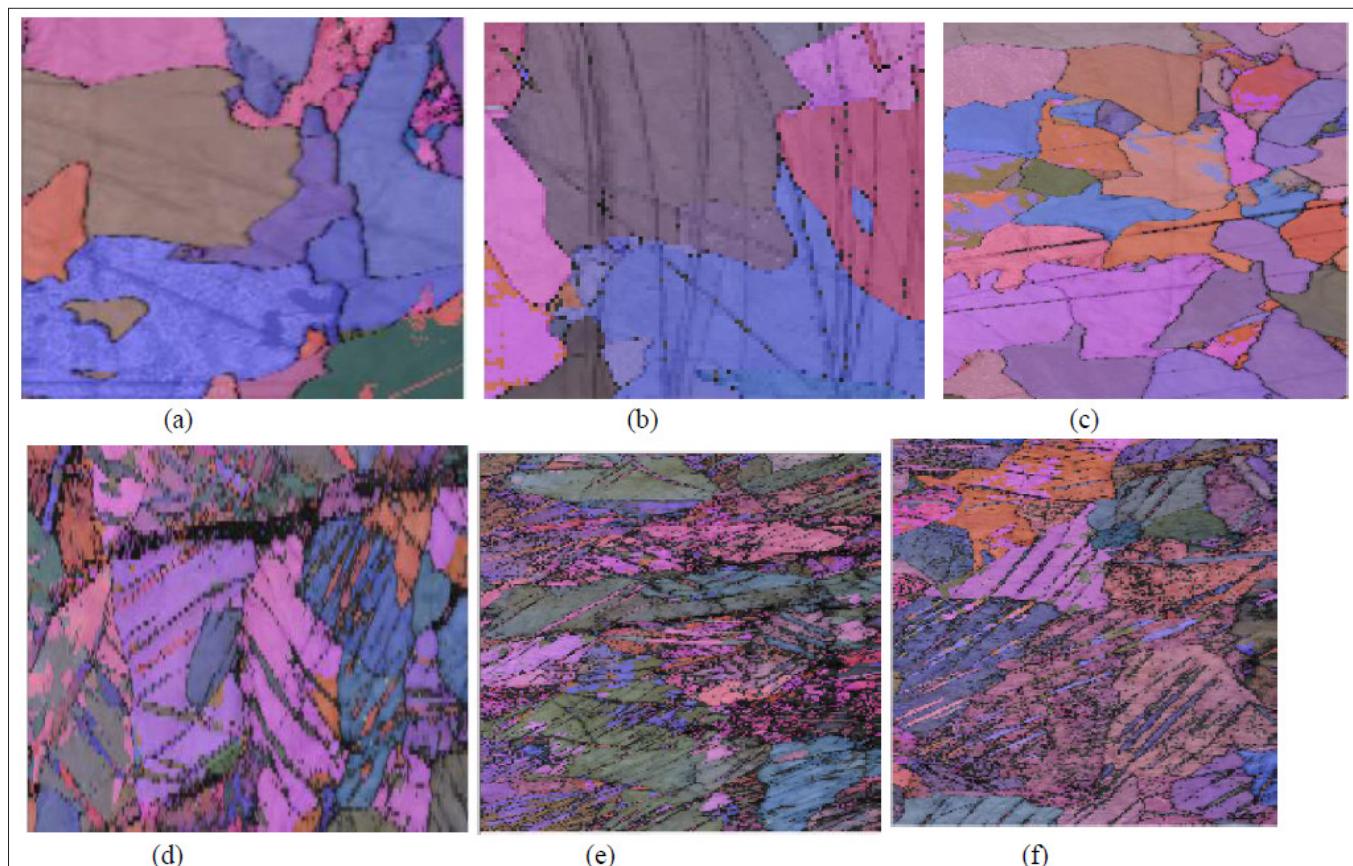
Figure 18: Sample for impacted A36 steel at 5.80 km/sec all cross-sections

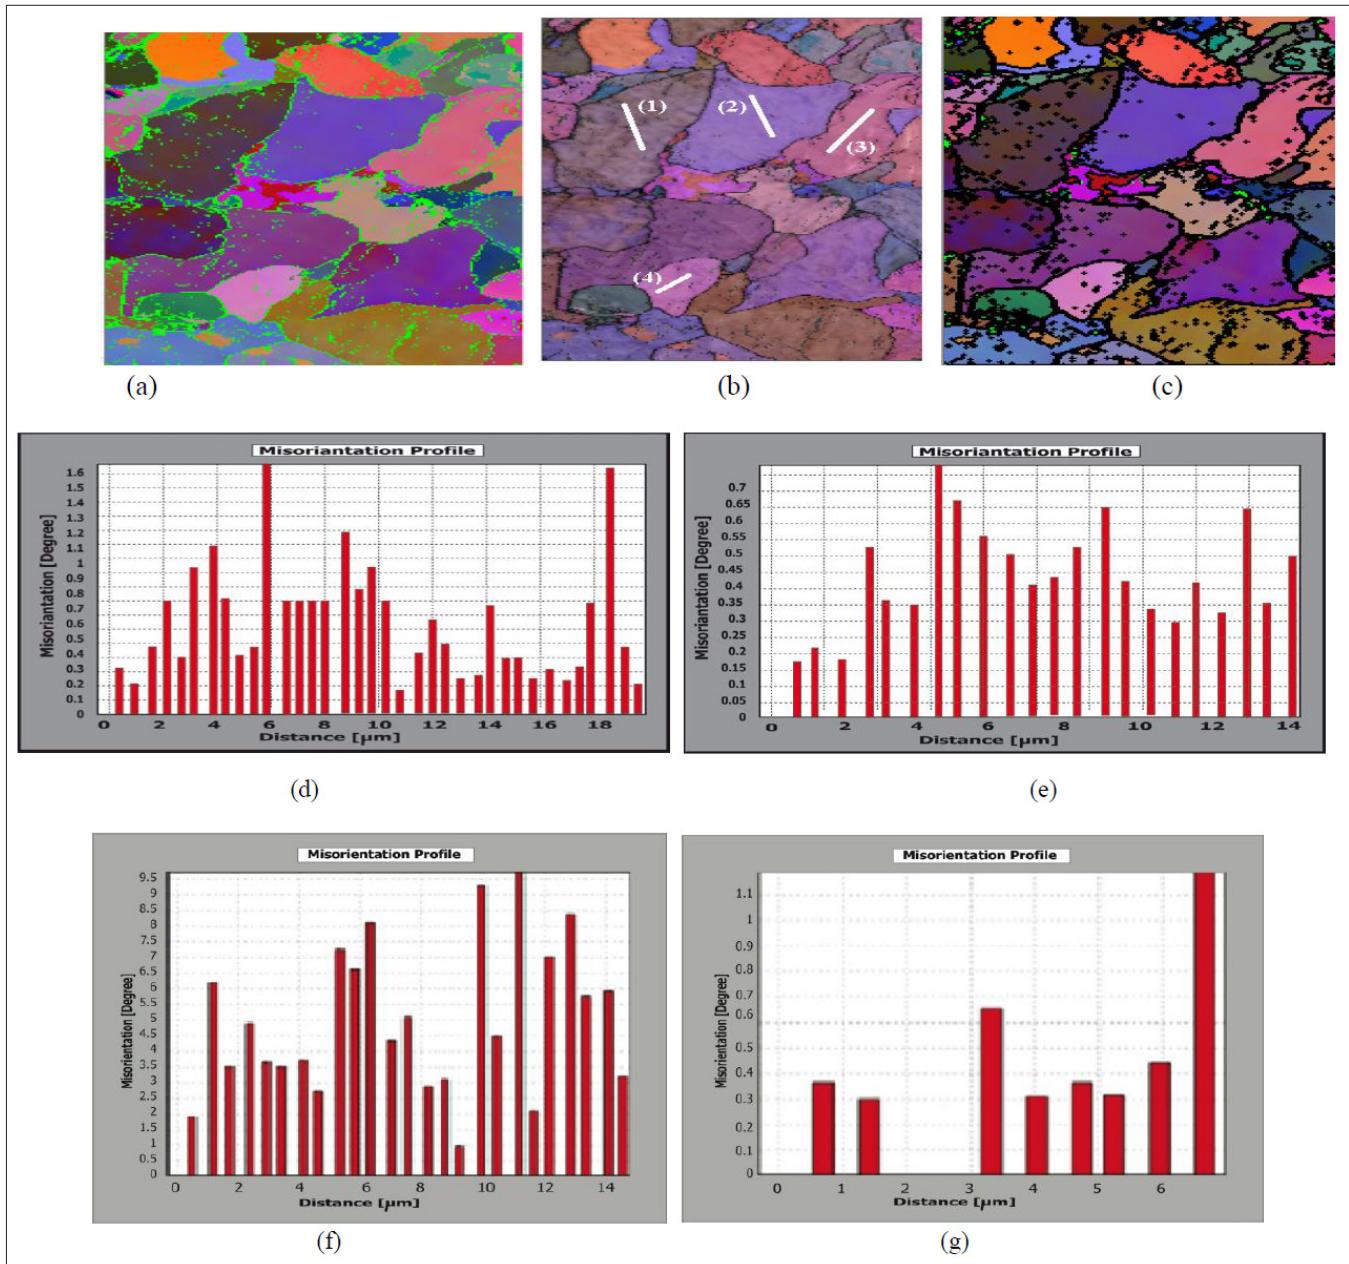
Figure 20: Misorientation angle measured along four different lines in the non-impacted A36 steel: a) EBSD shows less noise, b) EBSD shows grains, c) EBSD shows boundary grains d) Line 1, e) Line 2, f) Line 3, and g) line 4.

Transition in the grain boundaries of non-impact A36 steel, where the raw material is stable and clear, and the prominent grain of the misorientation angle is in small crystals ranging from 0-1.60° Misorientation measurement for A36 steel target at an impact velocity of 3.54 km/sec at sample location 6 results are shown in Figure15. Each line indicates that the angle is between 55-60° and the percentage of HCP is increased at the crater location at the impact for 3.54 km/sec impact speed.

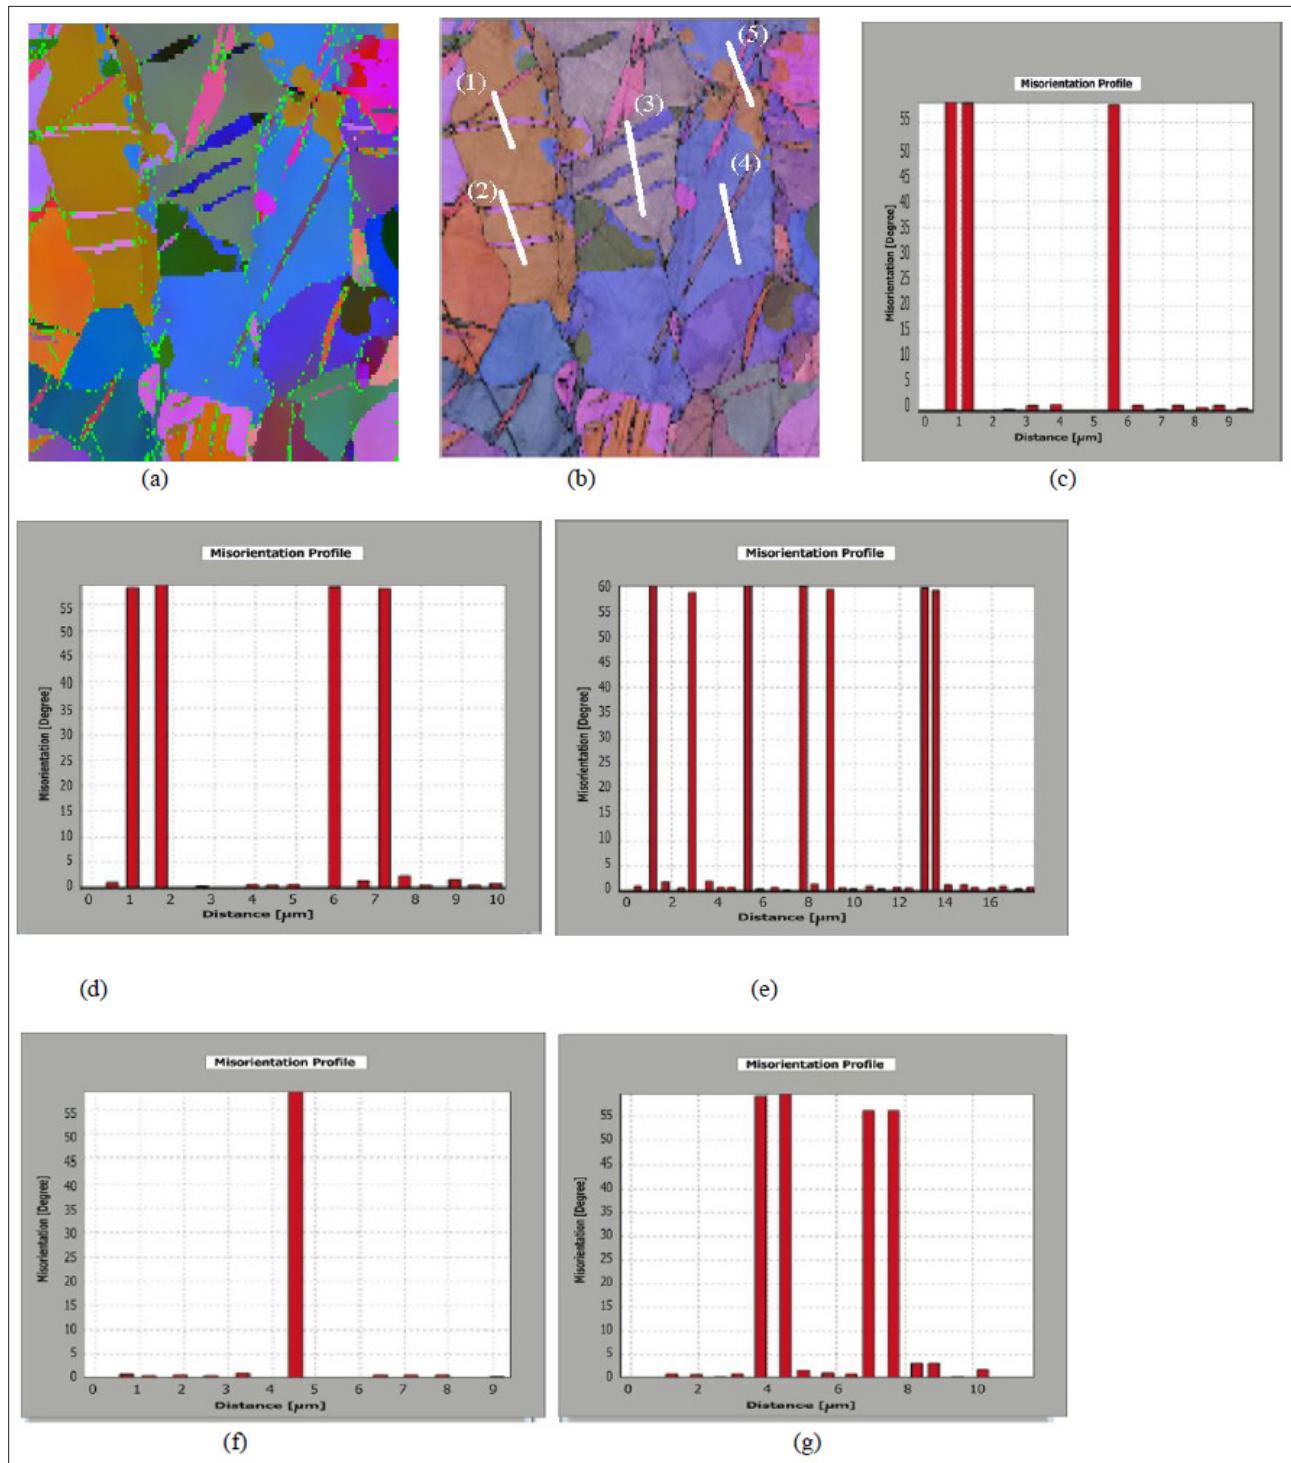
Figure 21: Misorientation angle measured along four different lines in the Impacted A36 steel, sample location 6-A, after impact velocity of 3.54 km/sec: a) less Noise, EBSD b) unenhanced grains; c) Line 1, d) Line 2, e) Line 3, f) Line 4 and G) line 5.

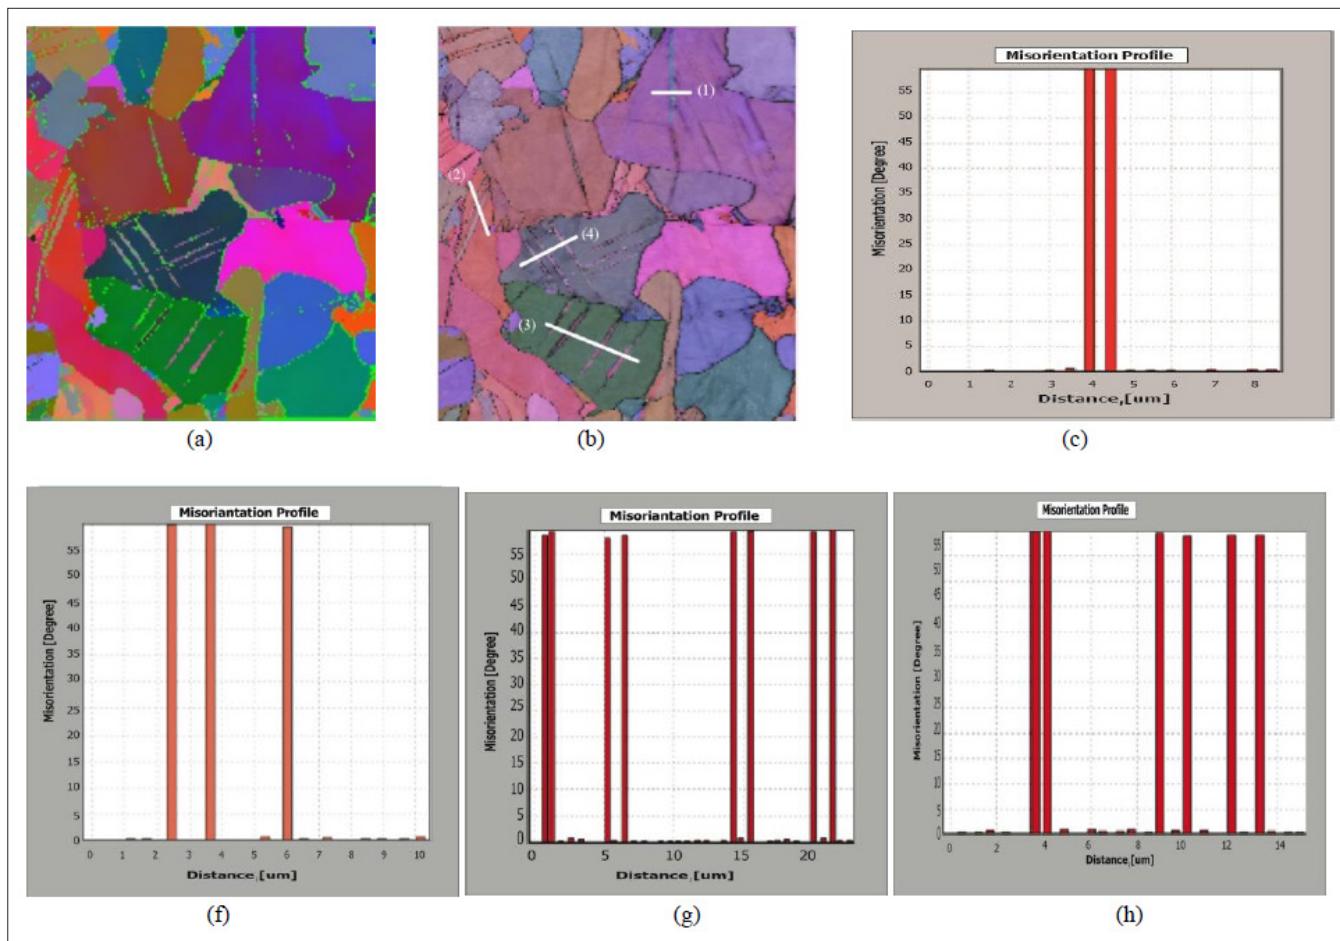
Figure 22: Misorientation angle measured along four different lines in the impact A36 steel, sample location 6-A, after impact velocity of 4.51 km/sec: a) EBSD shows less noise, b) EBSD shows grains; c) Line 1, d) Line 2, e) Line 3, and f) Line 4.

An impact crater at 4.51 km/sec misorientation measurement for A36 steel target with an impact velocity of 4.51 km/sec at sample location 6. Figure 16 shows the plastic deformation on A36 steel at 4.51 km/sec, and all lines that show the angle of this transformation is between (55-60°). The HCP phase was increased in this location, as well as twinning.

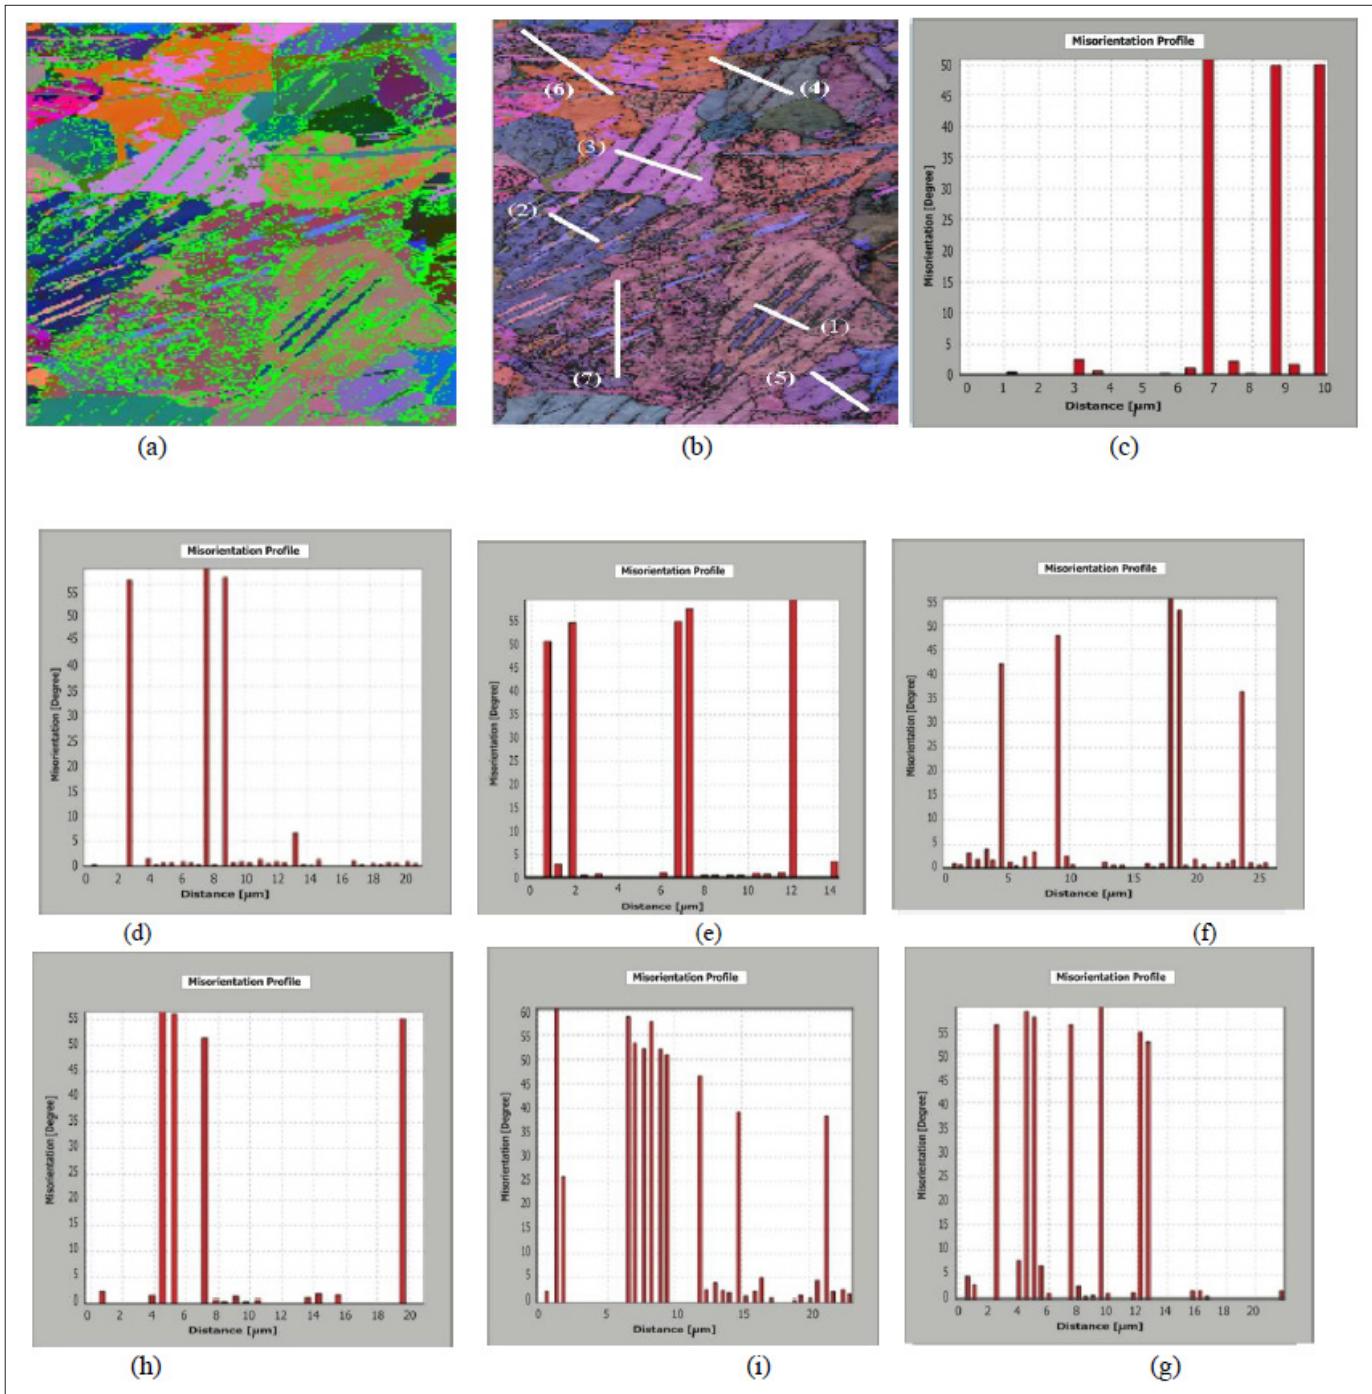
Figure 23: Misorientation for A36 steel at 5.80 km/sec impact. Sample location 6-G. Misorientation angle measured along four different lines in impact A36 steel, sample location 6-G, after impact velocity 5.80 km/sec: a) EBSD shows less noise, b) shows grains; c, d, e, f, g, h, and i) are lines 1, 2, 3, 4, 5, 6, and 7 respectively.

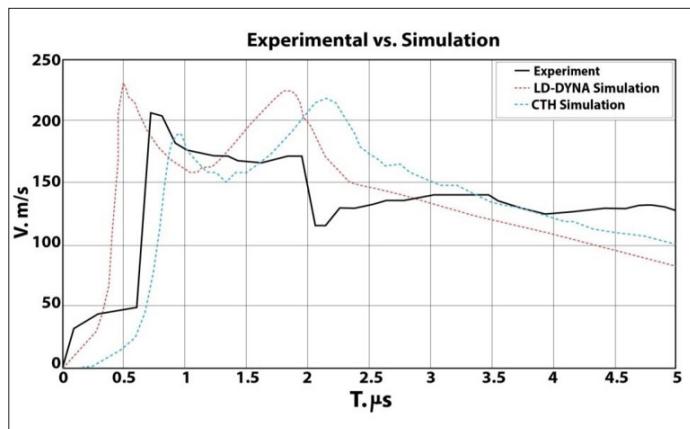
Figure 24: Experimental data and computational simulations of back face velocity versus time during the impact of a Lexan projectile (5.3 km/s) into an A36 steel plate [14].

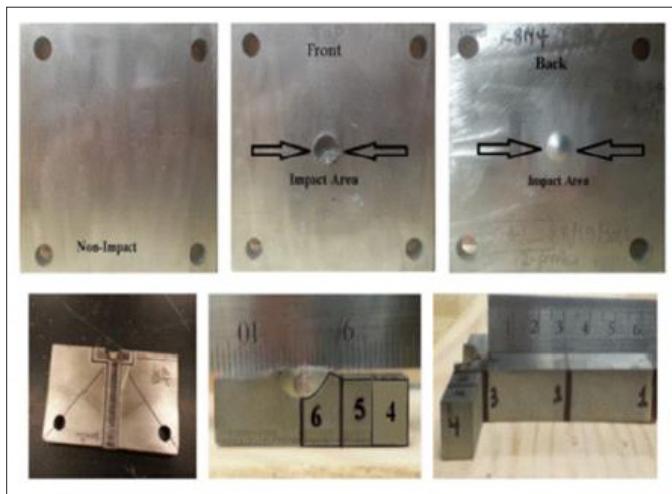
Figure 25: Non-impacts and Impact 304L steel and Impact at 6.58 km/sec. Location of six cross-sectional regions used for microstructural analysis

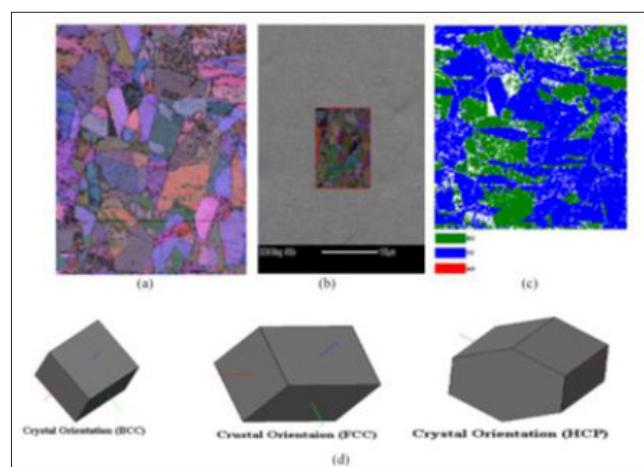
Figure 26: 304L Non-Impact microstructure photo of EBSD

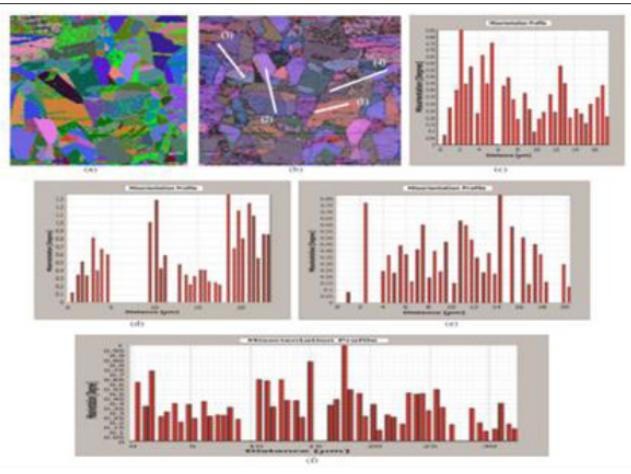
Figure 27: Misorientation angle measured along four different lines in the non-impacted 304L steel, the sample shows: a) EBSD shows less noise, b) EBSD shows grains, c) Line 1, d) Line 2, e) Line 3, and f) Line 4.

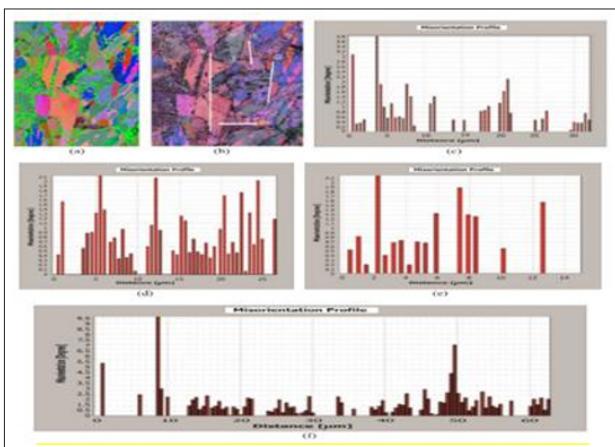
Figure 28: Misorientation angle measured along four different lines in the impacted 304L steel, sample location 6-A after impact velocity of 6.58 km/sec shows: a) EBSD shows less noise, b)

EBSD shows grains, c, d, e, and f are the Lines (1, 2, 3, and 4) respectively.

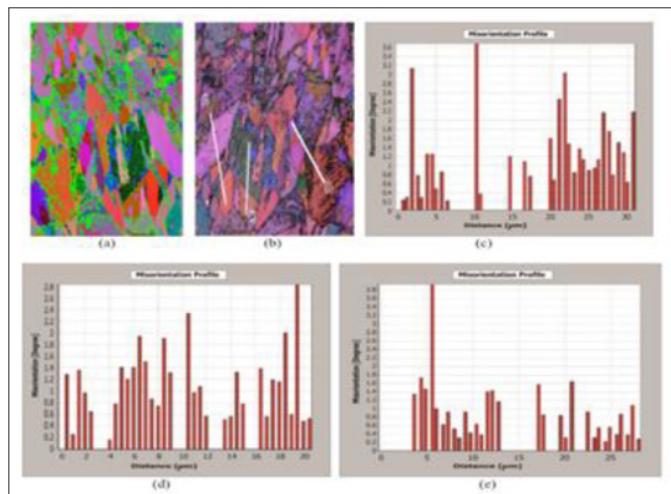
Figure 29: Misorientation angle measured along four different lines in the impacted 304L steel, sample location 6-B after impact velocity of 6.58 km/sec shows: a) EBSD shows less noise, b) EBSD grains, c) Line 1, d) Line 2, and e) Line 3.

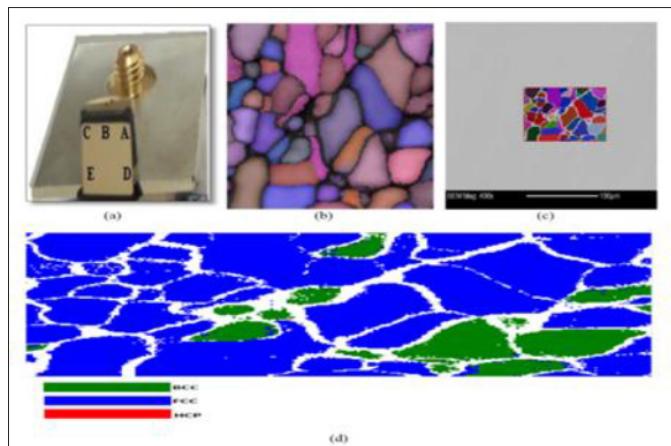
Figure 30: EBSD data from 304L steel, sample location 1-C, after impact velocity of 6.58 km/sec showing: a) polished sample, b) grain, c) 400X magnification and the original length of the map, and d) phase map.

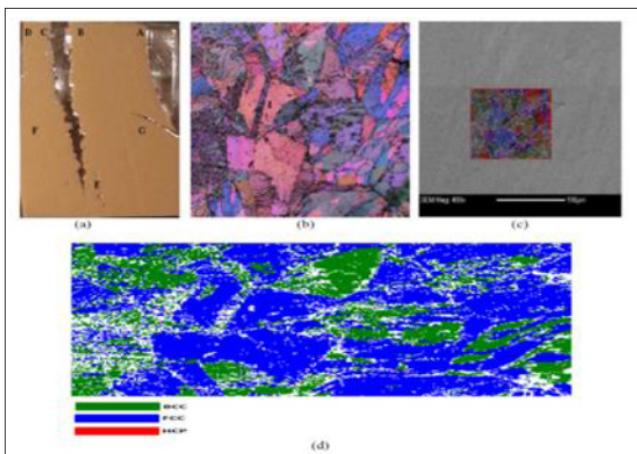
Figure 31: EBSD data from 304L steel, sample location 6-A, after impact velocity of 6.58 km/sec showing: a) polished sample, b) grain, c) 400X magnification and the original length of the map, and d) phase map.

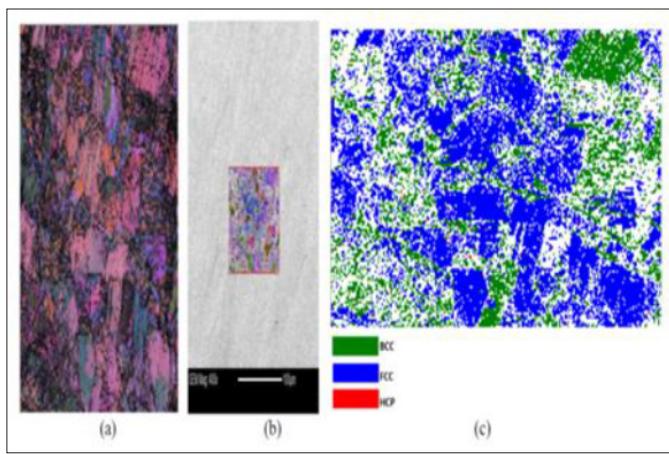
Figure 34: EBSD data from 304L steel, sample location 6-E, after impact velocity of 6.58 km/sec showing: a) grain, b) 400X magnification and the original length of the map, and c) phase map

Cross-section Location 6-E (0 mm from impact center): Figure-12 shows the EBSD microscopy data for location 6-E in the 304L steel target after an impact velocity of 6.58 km/sec. The figure shows the polished sample, grain, 400X magnification, the map's original length, and the phase distribution. No significant or dramatic changes occurred post-impact 304L steel under this high impact speed. Although the lowest impact affected A36 steel, let alone an even more effect on the HY100 steel, the existence of FCC having a high percentage significantly have affected the results. Before impact (BCC and FCC), since FCC is a transitional phase before transfer and reaches the hexagonal HCP phase. This is why the percentage of FCC is high through all locations of samples of 304L. The selection sample 6 locations C is a low percentage of error and higher confidence, as illustrated and discussed in chapters 6 and 7.

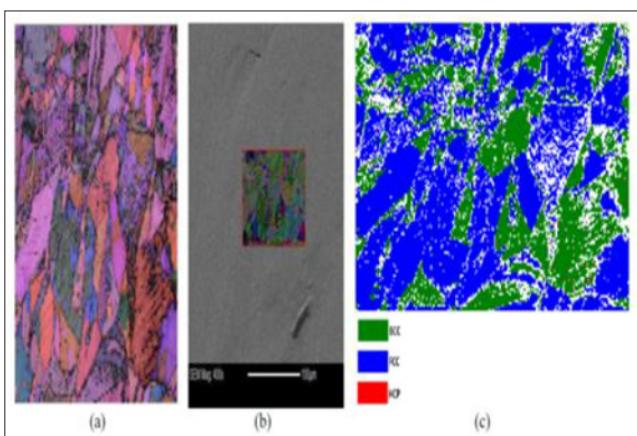
Figure 32: EBSD data from 304L steel, sample location 6-B, after impact velocity of 6.58 km/sec showing: a) grain, b) 400X magnification and the original length of the map, and c) phase map

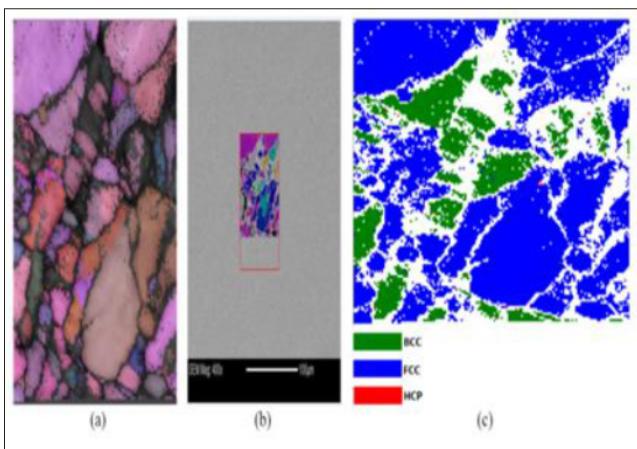
Figure 33: EBSD data from 304L steel, sample location 6-C after impact velocity of 6.58 km/sec showing: a) grain, b) 400X magnification and the original length of the map, and c) phase map.

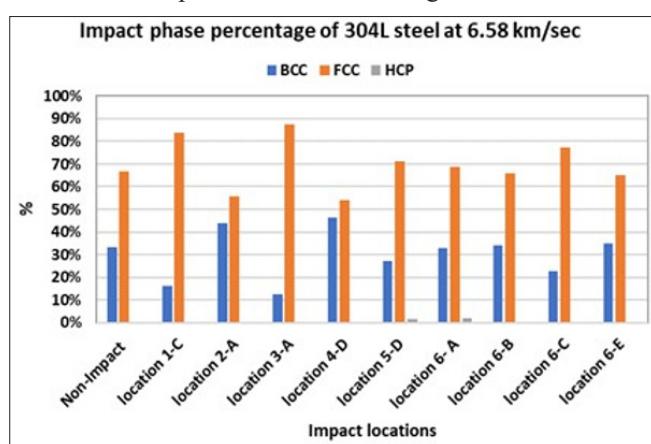
Figure 35: Impact phase percentage of 304L steel at 6.58 km/sec vs. all sample locations

At cross-section number 6, at the impact site, selected point C, at 1000 micron from the hole's edge, shows an insignificant value of HCP 0.092 % and 9.17 % accuracy. The location test of point A result has been ignored, which shows a low confidence error of more than 20 % and an HCP percentage of 1.699 %, which is less reliable than point C, as shown in Figure-13.

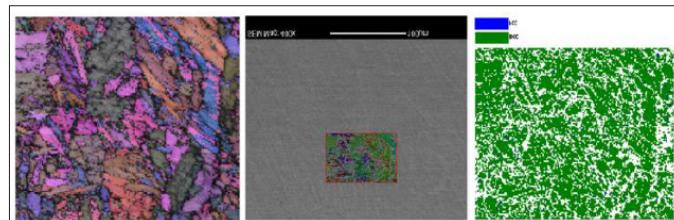
Figure 34: Non -Impact microstructure photo on EBSD

The images shown in Figure 6, obtained from EBSD microscopy, show the grain structure of HY-100 steel that has not been impacted. Figure 6 also indicates three views that explain grain, the 350X magnification, and the map and phase's original length. Table 2 lists non-impact material phase ratios. Transition and change locations of the grains inside the crystal of non-impact HY100 are examined. Before the shock, the angle ranging is (0-4.5) ° because the crystal system and stable raw material were not exposed to any load.

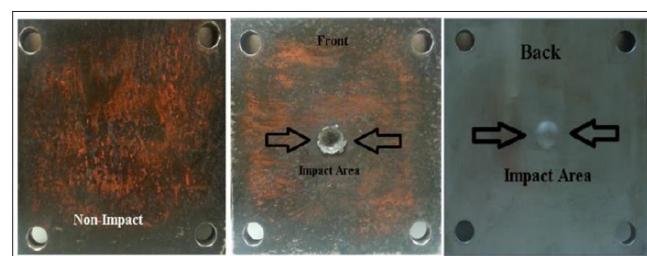
Figure 37: Non-Impacted HY100 Steel and Impact at 6.70 km/sec and sections of locations

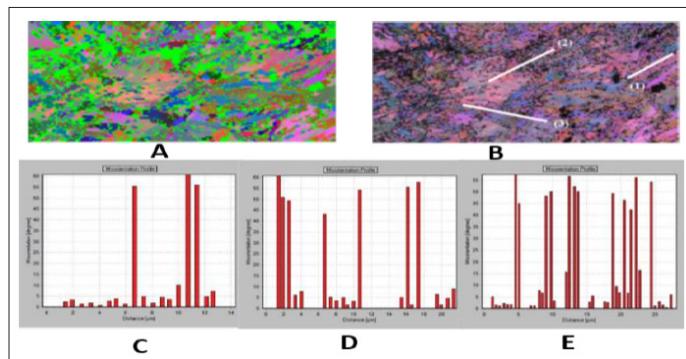
Figure 38: Impact HY100 Steel at 6.70 km/sec EBSD viewing less noise and EBSD considering grains. Lines (1, 2, 3) in sample (6) location B are grains misorientation at angle (0-60) degree twinning.

One HY-100 target plate from the impact velocity condition was evaluated. The geometry of the damage zone in the HY-100 target due to impact velocity is shown in Figure 7. Additionally, the depth and width of the hole on the front side are measured with a caliper. Enlarged views of the impact section give special attention in scanning for more than one point on that section's surface. Figure 8 shows the misorientation angle of the crater between 55-60°. The plastic deformation is deformed, and the grains dislocate the plane to another plane as a twinning deformation.

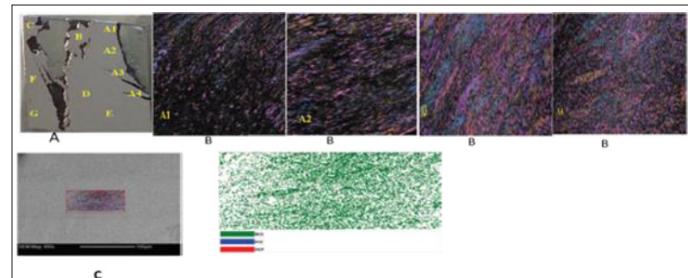
Figure 35: HY100 Steel sample (6) location A impact at 6.70 km/sec microstructure photo on EBSD. A) the Sample and locations, B) grain at four locations, C) 400X magnification and the original length of the map, and D) the Phases.

At Cross-section Location 6-A (0 mm from impact center), a small-grained size starts in the surrounding area arc crater due to the shock under the temperature and high-pressure. The error rate in this region high in the calculations was taken of the average of these areas. The best location is chosen to view EBSD microscopy images is shown in figure 9.
