Causes of Building Collapses

Armen Ohan

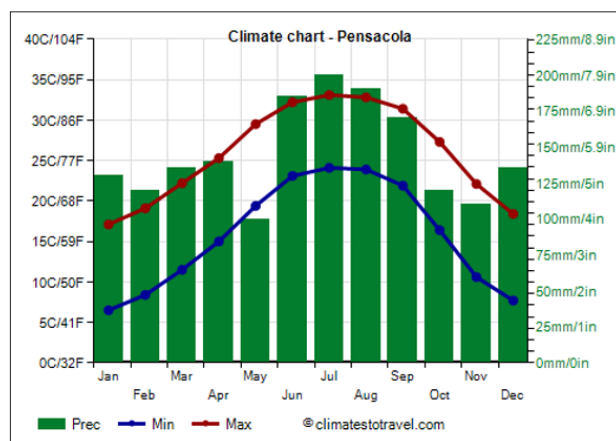
Illustration (1) shows the temperature rates in Florida during the year [12].

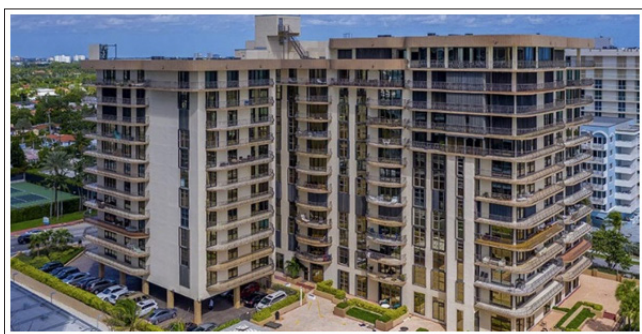
Image 1: is the photo of the Florida building before it collapsed.

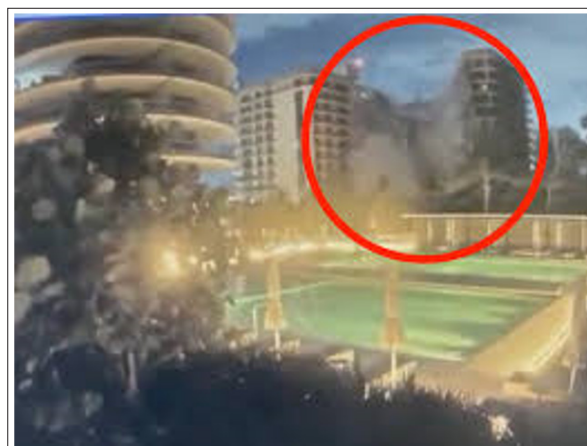
Image 2: Photo of the Florida building during the incident. [13]

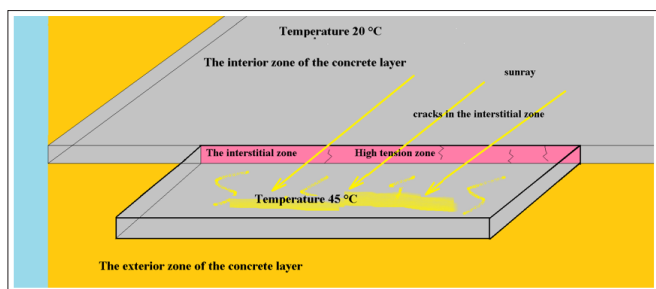
The illustration (2) shows the effect of the difference in expansion rates of the concrete layer for the interior and exterior zones of the building to form a high-tension zone, which leads to the creation of dangerous cracks in the interstitial zone that lead to its collapse.

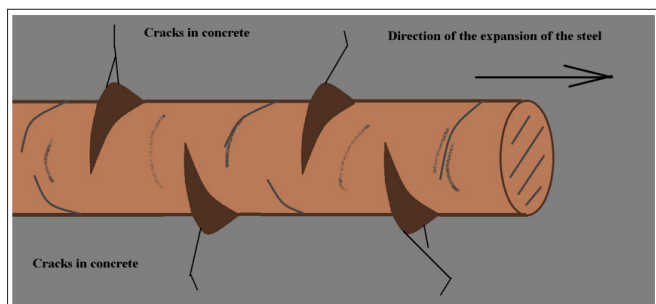
The illustration (3) shows how cracks occur in concrete due to an increase in the rate of expansion of Iron over the rate of expansion of concrete, especially in large buildings that use large amounts of iron and in high temperatures.

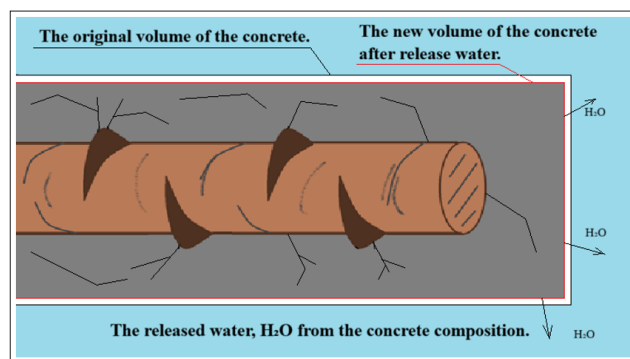
The illustration (4). The contraction in the volume of the concrete due to the release of water from its composition results in cracks, especially around the rest of the materials, which did not change their volume, such as steel or stone.

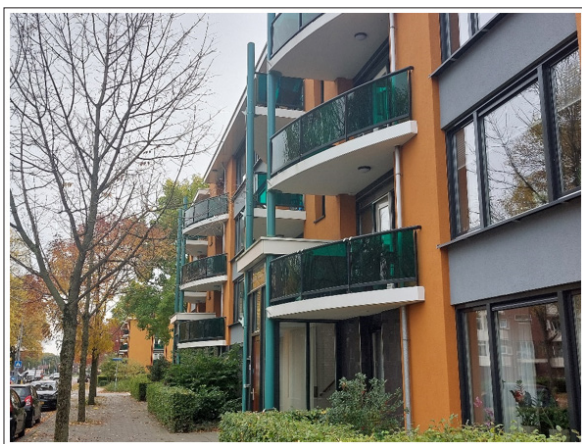
Image 3: One of the modern designs of buildings that uses columns to support balconies.

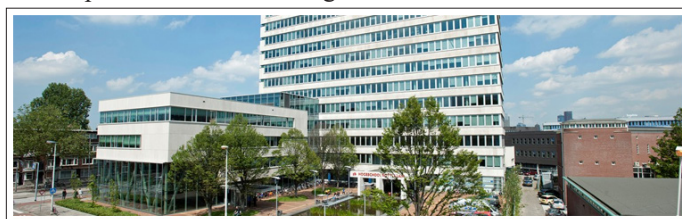
Image 4: Shows one of the modern buildings without any extending parts from the inside to the outside such as balconies

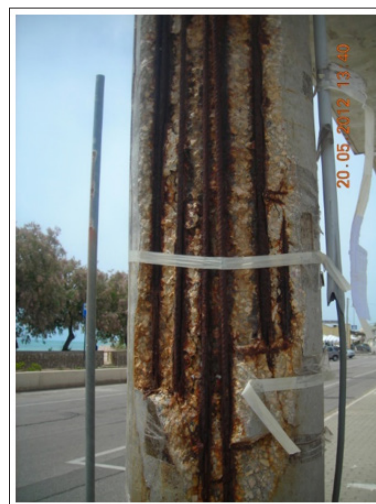
Image 5: Shows Iron rusts in concrete

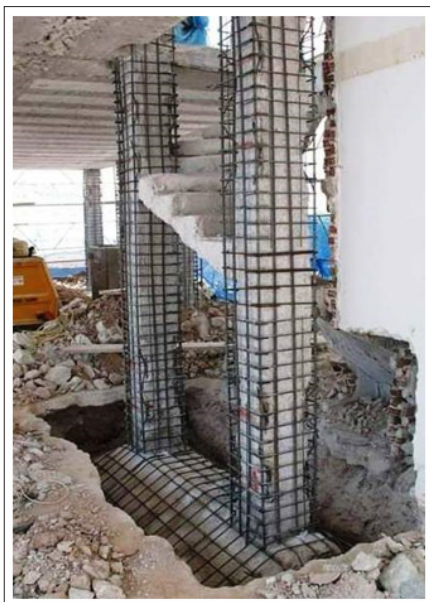
Image 6: Jacketing has advantage of increasing the member stiffness and is useful where deformations are to be controlled, and this design for strengthening is based on composite action between the old and new work because it's the issue of strengthening and retrofitting of existing structures, this method of maintenance is safe and does not endanger the safety of the building during maintenance [14]

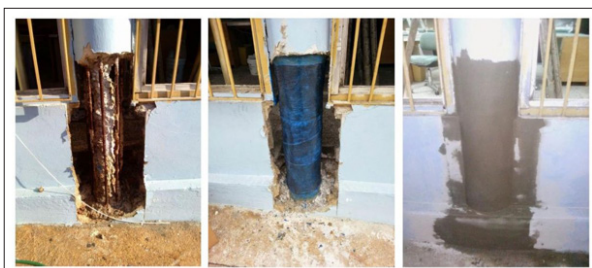
Image 7: Shows the process of corrosion column reinforced concrete repair [17,18].

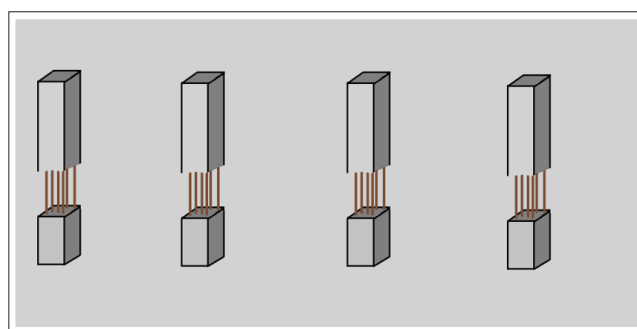
The illustration (5) shows the mistake that they make during the maintenance of working on many columns at the same time, where the concrete is removed from the columns for welding still pieces onto the rusted parts, where concrete is removed from a large number of columns for a long period, the building is exposed to the risk of uneven distribution of weights, which leads to the building falling during maintenance.

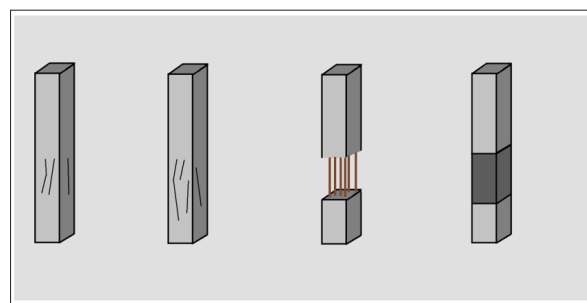
The illustration (6) shows the correct way of maintenance and working on columns one by one, to prevent the imbalance in the structure due to the heterogeneous distribution of the building weight on the remaining columns.

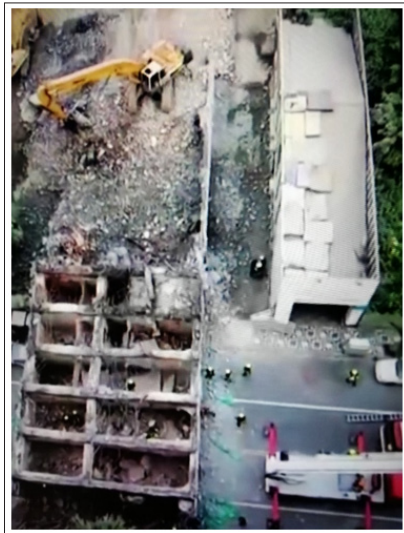
Image 8: Shows a collapsed building during maintenance due to remove several concrete columns.

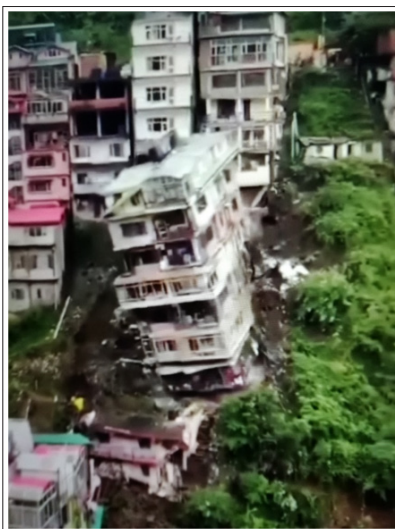
Image 9: Shows collapsed building during the flooding, where the humidity increases in the ground.

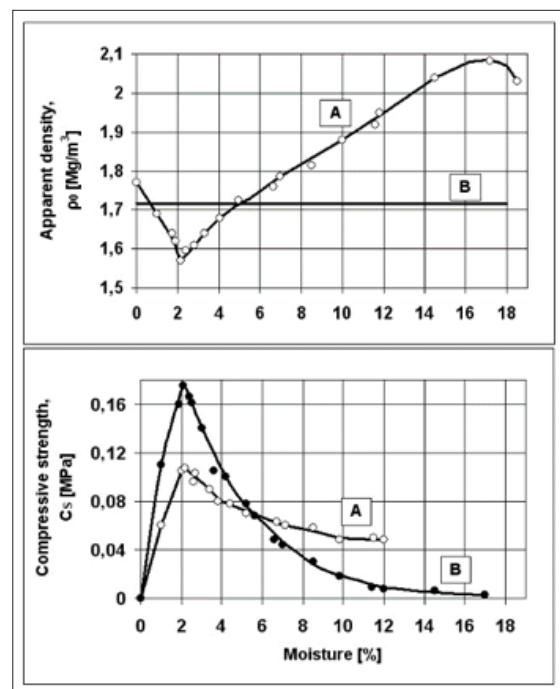
The illustration (7) influence of moisture on compressive strength of a green sand [19].
